# UptimeAI Prevents Separator Failure and Saves \$150K at a Leading Cement Plant

## Customer Profile

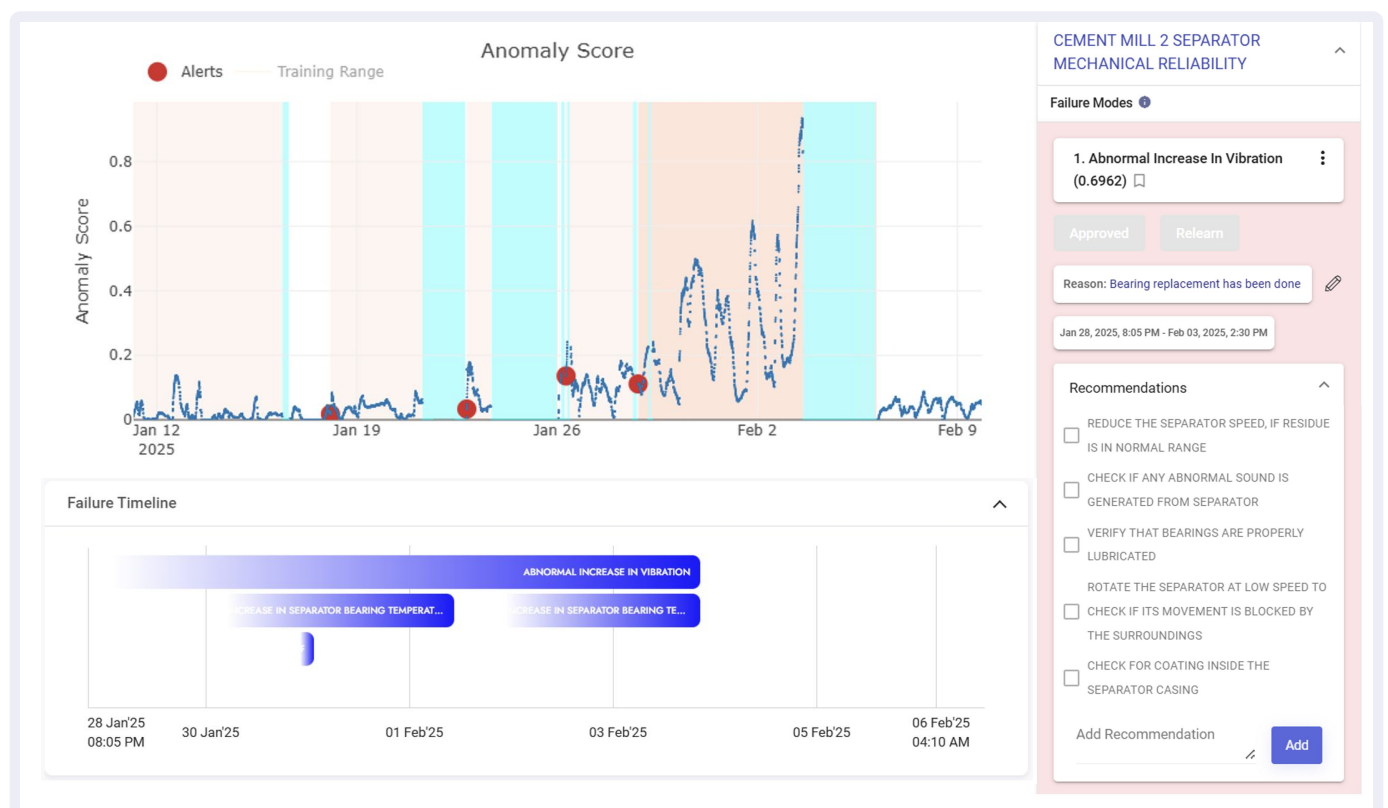
- Continuous AI monitoring detected abnormal SEPAX vibration and rising bearing temperature.
- The system issued multiple alerts on January 18, 26, and 29, indicating progressive degradation.
- The reliable alerts with vibration time series data were used by the plant team to validate the potential failure mode and plan timely corrective actions.

- Correlation across 12 parameters ruled out issues in the motor and gearbox.
- AI-driven analysis identified **bearing vibration** as the trigger, which was **leading to bearing degradation**.
- Historical trends confirmed **progressive wear that was leading to a potential failure**.

- UptimeAI's recommendations suggested bearing replacement during the upcoming maintenance window.
- The team proactively procured spare parts in advance, minimizing downtime and maximizing preparedness.
- On February 5, the bearing was successfully replaced, restoring the separator's full functionality.
